Earth Dam Failure by Erosion, A Case History

EARTH DAM FAILURE BY EROSION, A CASE HISTORY

In January 1998, the Archusa Creek Dam in southeast Mississippi failed by breaching through its emergency spillway. At the time of its failure, the dam had a concrete ogee weir for a principal spillway and a vegetated earth emergency spillway. Fortunately, the dam is a low hazard structure, as there is little development downstream, and consequences of failure were mostly limited to the loss of a state-owned, recreational water park. The dam failed as a result of a 5-year storm event, triggered by intense rainfall of nearly 4.25 in. in just a few hours. Runoff generated by the storm caused a rapid rise in lake level to elevation above the flood pool, resulting in flow over the emergency spillway. A breach then formed through the emergency spillway due to progressive erosion and head-cutting caused by excessive water flow velocity, a well-known failure mechanism. This paper examines how the failure happened, including the aspects leading up to the breach. Hydrologic, hydraulic, and geotechnical aspects of the failure are discussed, including the dam's design and subsequent modifications, its

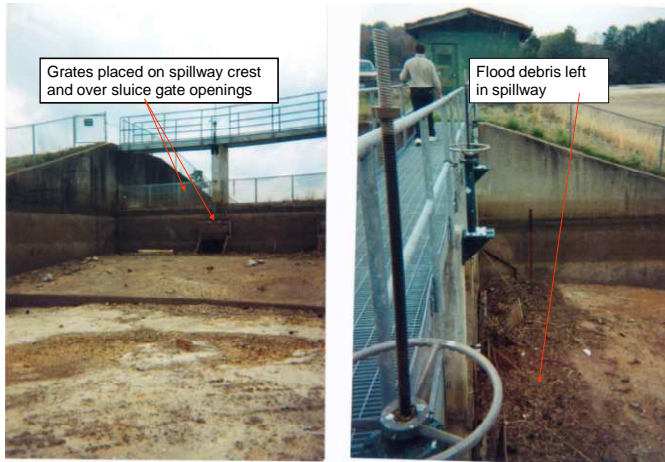
In the 1980s, the principal spillway was fitted with an inflatable gate; this configuration was modified in 1994 due to ongoing problems with maintenance and vandalism. In 1994, the spillway was modified with an ogee crest and series of sluice gates through the ogee. The crest and the gate inlets were all fitted with fish-retaining screens. Figure 2 illustrates these spillway modifications. Notably, the fish-retaining screens clogged with debris during the failure storm and contributed to breaching by restricting spillway capacity.

Fig. 2. Photo showing spillway modifications.

The modification to the principal spillway added another element for potential failure. Changes in the principal spillway included the addition of an ogee weir with manual sluice gates. The gates and the weir crest were all fitted with fish-retaining grates, as illustrated in Fig. 2. As Fig. 2 illustrates, the grates collected significant debris during the storm event, consequently restricting flow capacity through and over the spillway. The reduced capacity from the clogged grates was probably never envisioned or accounted for in the dam modification. While the disadvantage of grates over the spillway openings is evident, there is little known benefit.

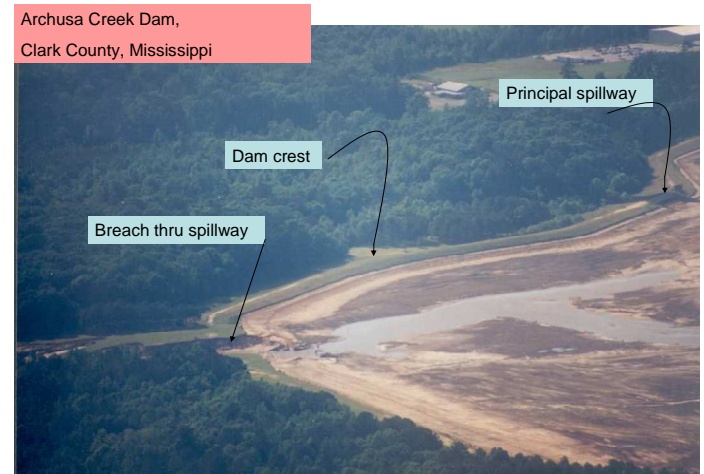
The breach was formed by the erosion of soil within the vegetated earth emergency spillway due to the high discharge velocity, which the spillway surface could not sustain. Figures 3 and 4 illustrate the position of the breach within the dam. The storm causing the failure was an event corresponding to a 5-year return period. Rainfall from this storm was nearly 16.5 cm (6.5 in.) in a 3-day period. However, the dam's failure was preceded by intense rainfall of 10.8 cm (4.25 in.) over a period of only a few hours. Figure 5 illustrates the grass lining on the emergency spillway, and shows the fine sand soil within the spillway. Figure 6 illustrates the lake's shallow depth (note

Fig. 3. Breach through emergency spillway.

The dam breach was actually an over-topping failure. Because the earth emergency spillway was located in the interior of the dam (versus at an abutment), and built on fill (versus in cut), water flowing over this surface was essentially the same as flowing over the dam.

A concrete labyrinth weir spillway was selected as the main repair component; it was built within the gully made by the breach. This new concrete spillway, now used as an auxiliary spillway, has helped designers solve the problem of flow over an earthen emergency spillway at a 2-year frequency and should prevent such a disaster in the future.

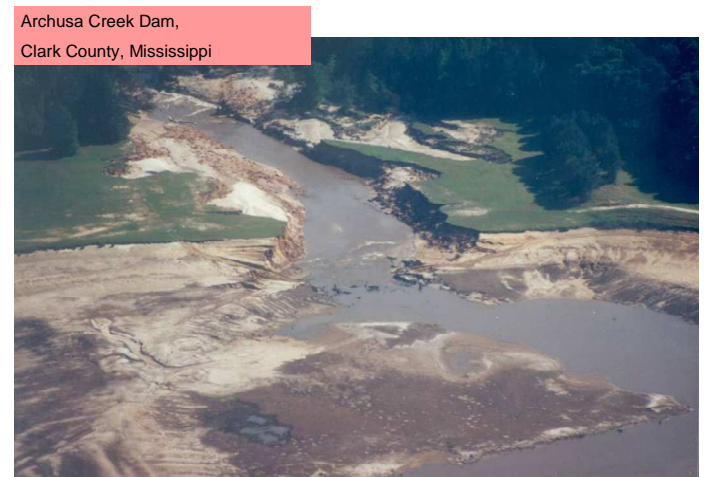
Fig. 4. Close-up view of breach.

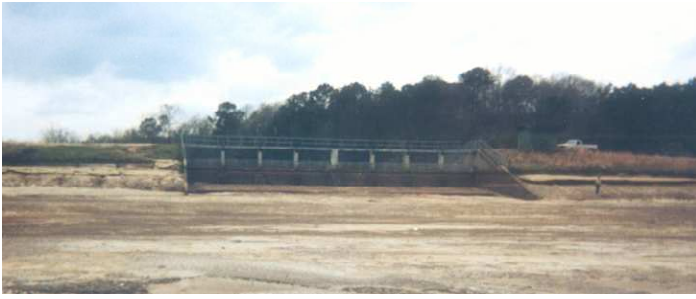
the person standing to the right of the spillway, indicating relative scale).

Fig. 6. Photo illustrating principal spillway and typical depth of lake.
